# BULLETIN

## THE NATIONAL TRANSPORT UNIVERSITY

## Effect of aggressive environments and stray currents on the corrosion resistance of corrugated metal pipes

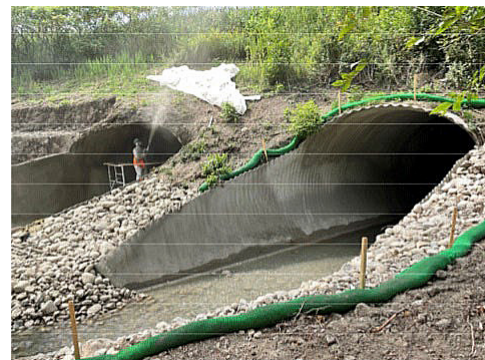
**Figure 1.** A practical example of the restoration of a corrosion-damaged corrugated metal pipe using GeoSpray geopolymer coating

| Event description | Subject of analysis / engineering solution | Engineering value for transport infrastructure |
|---|---|---|
| Corrosion-damaged corrugated metal culverts, for which traditional replacement was too expensive or would have had a significant impact on traffic | The rehabilitation was conducted by applying GeoSpray geopolymer coating to the actual transport infrastructure | The effectiveness of trenchless solutions for restoring a structure's functionality without significantly impacting the operation of the infrastructure |

The presented examples have shown that the corrosion-induced degradation of corrugated metal pipes is not merely a process of material wear and tear, but also a factor contributing to the loss of serviceability and a reduction in the structural reliability of the structure. In particular, the collapse of a corrugated pipe due to a combination of localised pitting corrosion and degradation of the soil environment demonstrated that such damage could lead to a complete loss of serviceability and the need for immediate engineering intervention (Giresini *et al.*, 2015). At the same time, the use of an internal composite liner confirmed the possibility of restoring the pipe's structural integrity without its complete replacement and extending its service life (Taha & Murcia, 2021). Rehabilitation using GeoSpray geopolymer coating has demonstrated the effectiveness of trenchless restoration in situations where traditional replacement would be prohibitively expensive or would entail significant operational restrictions (Liao *et al.*, 2022). The necessity of reinforcing damaged corrugated structures, especially under intensive operational loads, highlights that corrosion-induced weakening must be considered in the context of restoring load-bearing capacity and ensuring the overall safety of transport infrastructure (Luchko & Kovalchuk, 2021; Harkusha, 2023). Thus, the analysed cases confirm that corrosion damage to metal corrugated pipes provides grounds for decisions regarding the reinforcement, rehabilitation or restriction of a structure's operation. As an example of practical application, a field project is presented involving the rehabilitation of a corrosion-damaged corrugated metal pipe using GeoSpray geopolymer coating (Fig. 1).
